EXCELLENT HOME INSPECTION SERVICES

123 Daisy Ct, Greenwood, Indiana

Inspection prepared for: Jon and Alley Smith

Date of Inspection: 6/5/2013 Size: about 4,000 sq ft

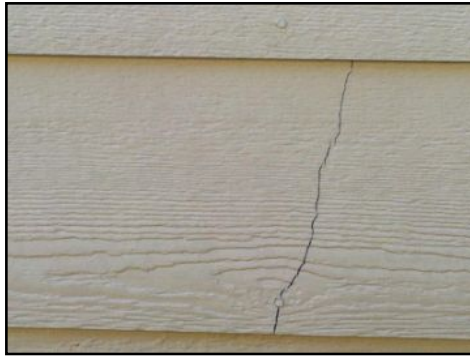
- Caulk wall penetrations caused by faucets and utility entrance points.
- Siding was damaged.

Siding was damaged.

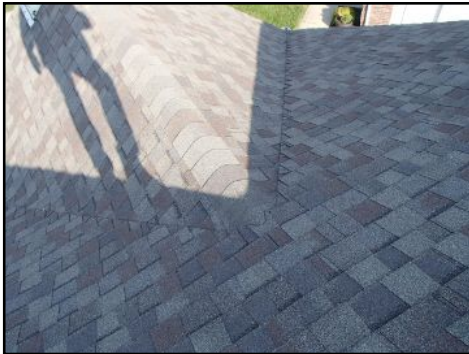
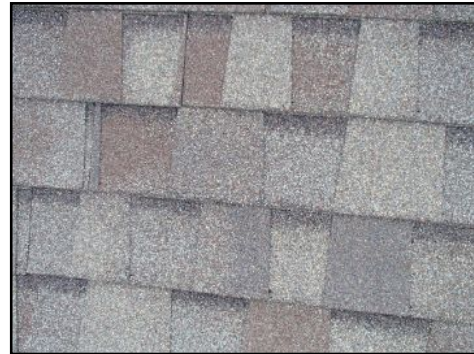
Shingles were in good condition

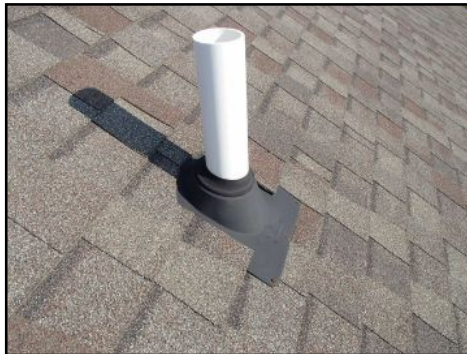
Plumbing boot was in good condition

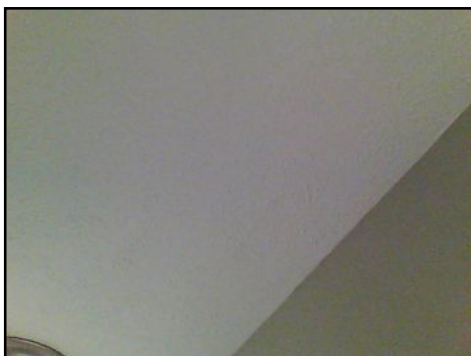
Roof leak above the window

| Page 6 | Other | <ul style="list-style-type: none"> • The ceiling had moisture stains that were wet at the time of inspection. I recommend finding the water source and fixing it. |

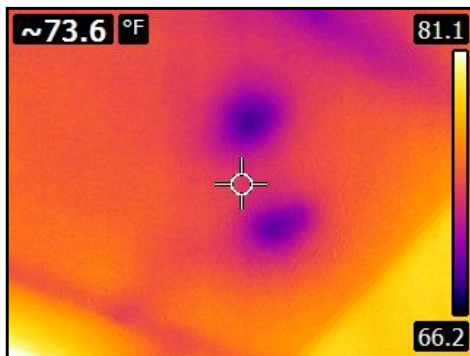
Thermal image of roof leak above the window

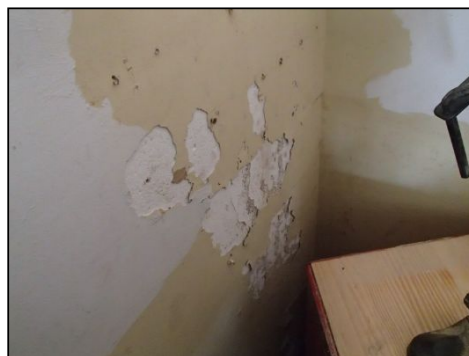
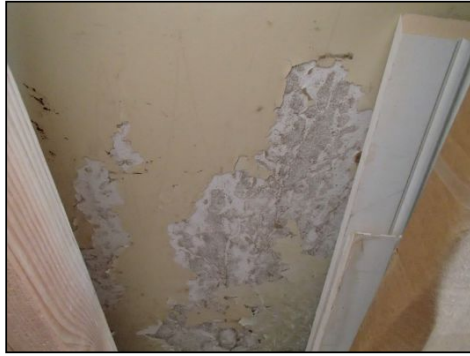
- Wood Destroying Insect damage or activity was found. Since the inspection is visual and I cannot see behind finished surfaces, insulation, or other obstructions, I cannot tell the full extent of the damage. See WDI report for more information.
- The ceiling had moisture stains that were wet at the time of inspection. I recommend finding the water source and fixing it.

termites ate the paper off of the drywall

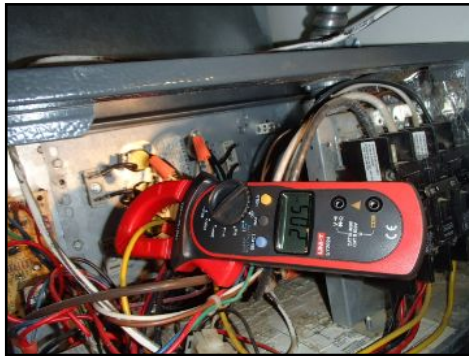
Backup electric heat was operable.

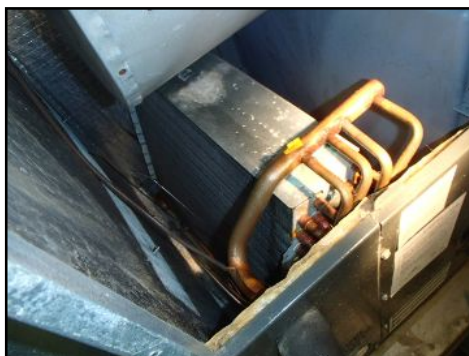
Evaporator coil was operable.

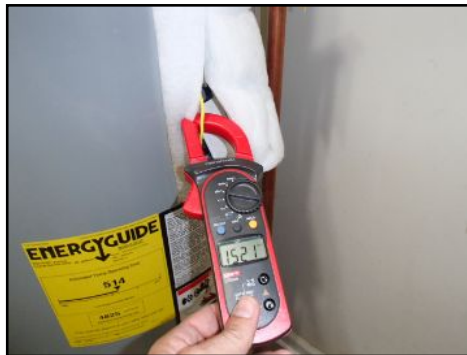
Upper element was operable

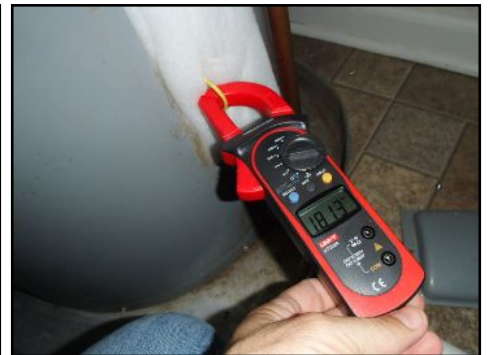
Lower element was operable

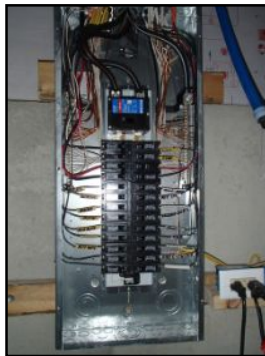
- The breaker for the air conditioner was higher than the manufacturers maximum rating on the data tag. I recommend repair.

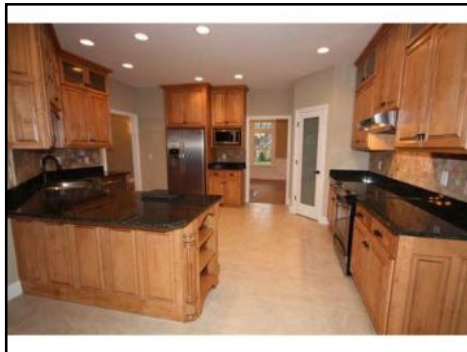
- GFCI was inoperable. I recommend repair.
- A plumbing leak was found under the sink. I recommend repair.

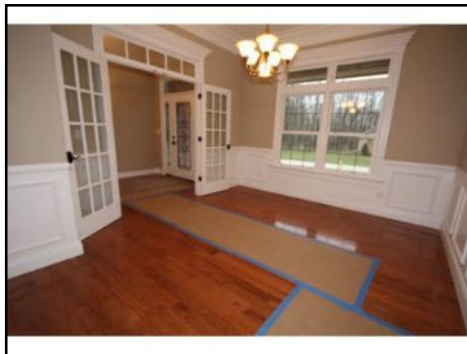
- Window would not open.

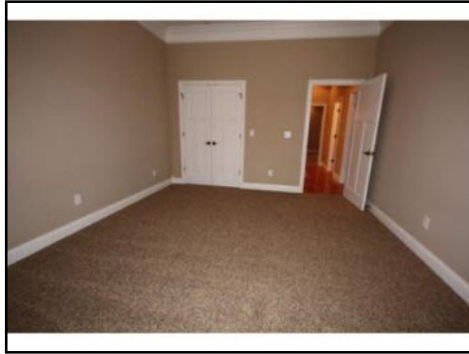
- Window latch was inoperable.

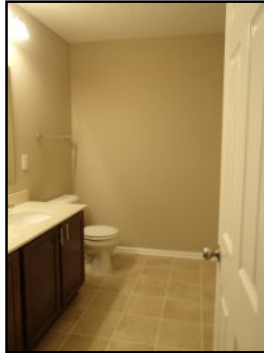
- Toilet was not firmly attached to the plumbing flange. I recommend repair.
